**Flood Control Project Maintenance
Levee Inspections****LMA District Cover Sheet
Spring 2015 Levee Inspection Results****Reclamation District No. 1500 Sutter Basin**

Spring 2015 Levee Inspection Results

Reclamation District No. 1500 Sutter Basin

Waterway			Bank	Unit Miles
Unit No. 01 Sacramento River			Left	33.15
	Spring (March - May)	Summer (June - August)	(September - November) Fall	Winter (December - February)
Unit Maintenance Rating (Fall Only)				
Date of Inspection	05/13/2015 - 05/14/2015			
DWR Inspector	Jai Lor			
Accompanied By

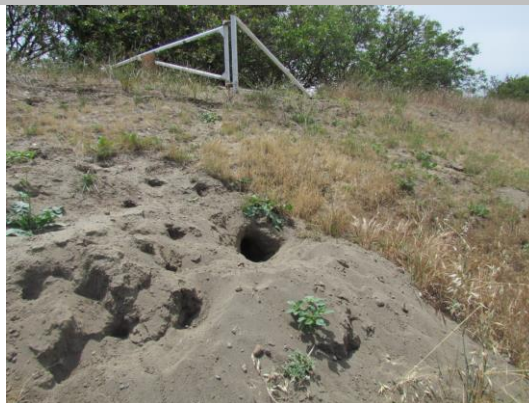
Photo 1 of 1 : SP_2015_RD1500_189_1681_20150514_03098.jpg

View of the animal burrow on the landward side of the levee looking upstream. The hole seems to be freshly dug. Spring 2015.

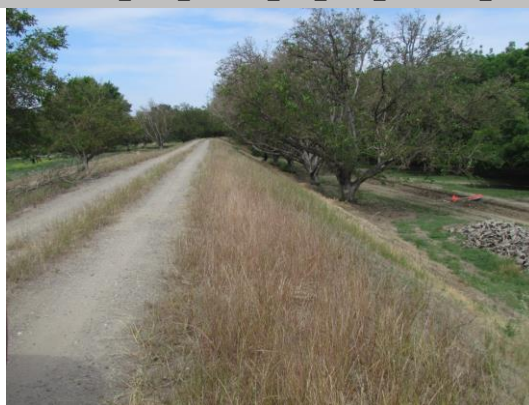
Photo 1 of 1 : SP_2015_RD1500_189_2533_20150514_03090.jpg

View of the vegetation on the landward side of the levee looking upstream. Spring 2015.

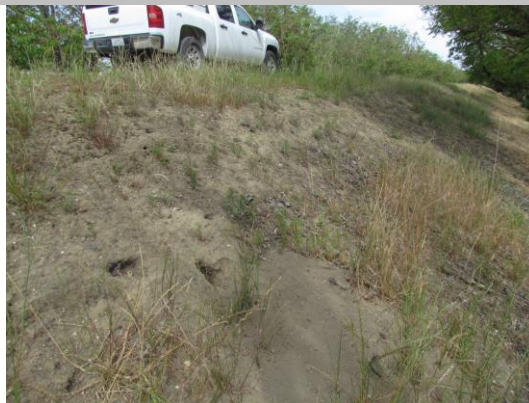
Photo 1 of 1 : SP_2015_RD1500_189_2535_20150514_03091.jpg

View of the animal burrow on the landward side of the levee looking upstream. Spring 2015.

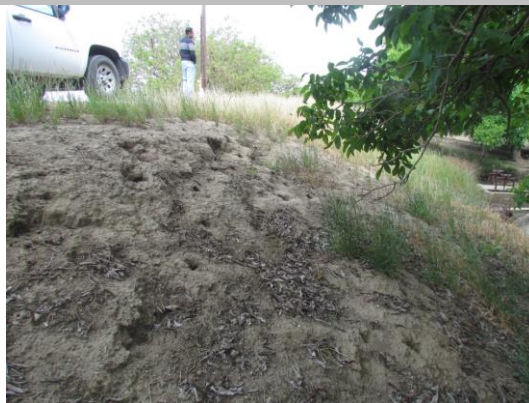
Photo 1 of 1 : SP_2015_RD1500_189_2538_20150514_03092.jpg

View of the animal burrows on the landward side of the levee looking upstream. Spring 2015.

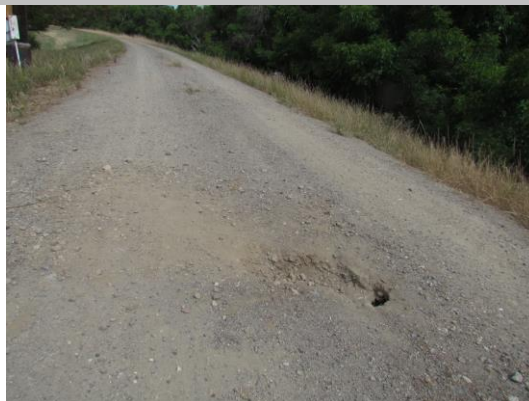
Photo 1 of 1 : SP_2015_RD1500_189_2540_20150514_03093.jpg

LM Start	0.31	Rating **	M	Issue No.	2540
LM End	0.31	Issue Type +	Ma	Location *	CR
Category	Earthen Levee			GPS Latitude/Longitude	
				Start	End
Item	Animal Control			38.763154 °	38.763154 °
				-121.678967 °	-121.678967 °
DWR ID	DWR_RD1500_01_s _ 2015_2540				
Action/Comments					
Exterminate rodents and backfill and compact or grout burrows.

Perspective view of the animal burrow on the crown of the levee looking upstream. Spring 2015.

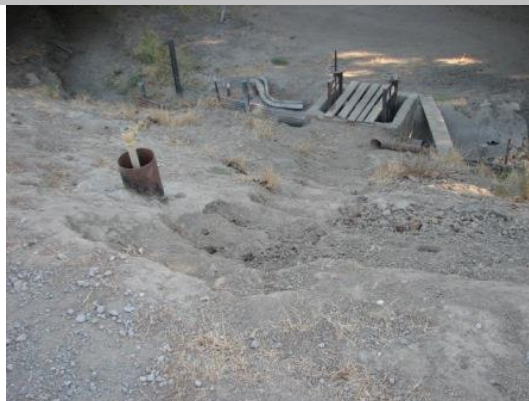
Photo 1 of 1 : SP_2015_RD1500_189_53_20150401_00044.jpg

Steps carved into the levee slope at a pipe crossing. Photo fall 2012.

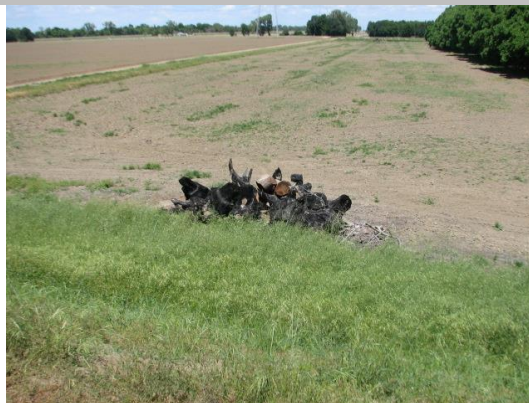
Photo 1 of 1 : SP_2015_RD1500_189_1336_20150401_00080.jpg

Large stumps piled up at the toe of the levee. Spring 2014

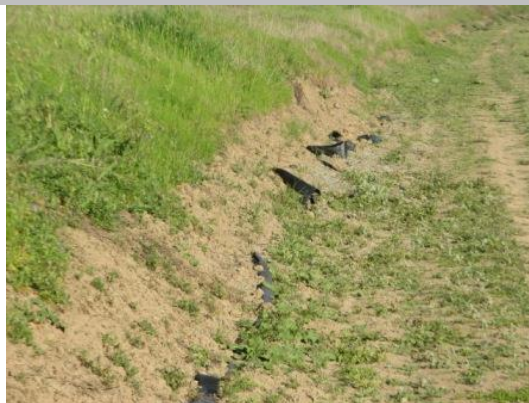
Photo 1 of 2 : SP_2015_RD1500_189_76_20150401_00054.jpg

LM Start	0.63	Rating **	A/W	Issue No.	76
LM End	1.05	Issue Type +	Ma	Location *	LS
Category	Earthen Levee			GPS Latitude/Longitude	
				Start	End
Item	Slope Stability			38.764305 °	38.766827 °
				-121.684396 °	-121.690884 °
DWR ID	DWR_RD1500_01_s _ 2013_76				
Action/Comments					
Repair slope instability. Inspector Comments: Seepage berm was damaged last fall in prep for the agricultural field and needs to be restored by the land owner. A field investigation report was made. The seepage berm is scheduled to be repaired before next flood season.

Damage to the seepage berm during the flood season needs to be repaired, Spring 2013

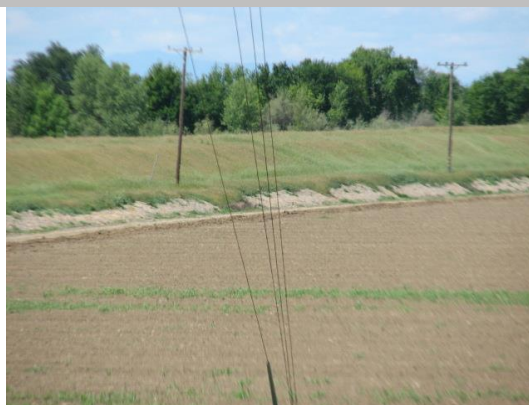
Photo 2 of 2 : SP_2015_RD1500_189_76_20150401_00055.jpg

The damage to the seepage berm has been repaired and needs to be monitored. Spring 2014

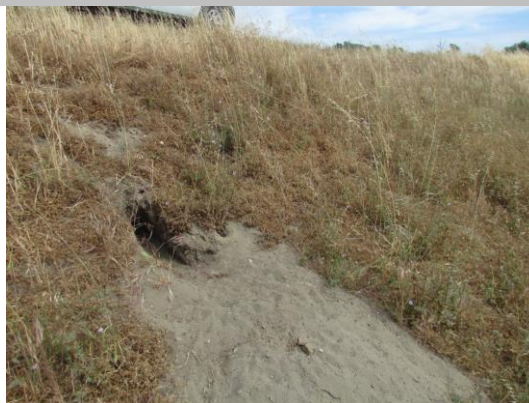
Photo 1 of 1 : SP_2015_RD1500_189_2543_20150514_03094.jpg

View of the animal burrow on the landward side of the levee looking upstream. Spring 2015.

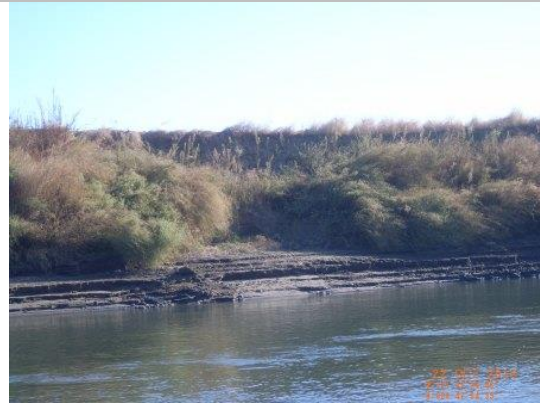
Photo 1 of 1 : SP_2015_RD1500_189_2_20150401_00002.jpg

Action/Comments					
Inspector Comments: 2010 - The upstream end of the repair site at 87.0. Repair did not extend far enough upstream. 2011 - New erosion pockets. 2012 - Minor new erosion at toe. 2013: Minor new erosion. [2013 Site ID: SAC_87-1_L]

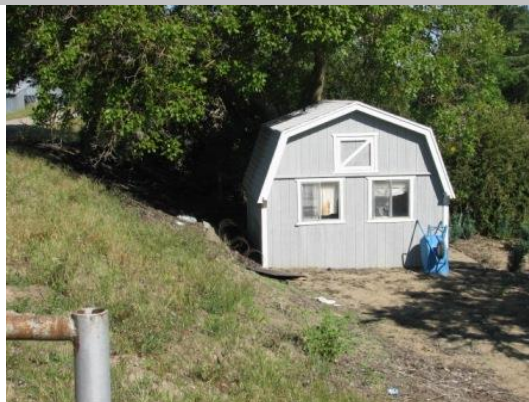
Photo 1 of 2 : SP_2015_RD1500_189_7_20150401_00005.jpg

A small building is encroaching into the landside levee toe.

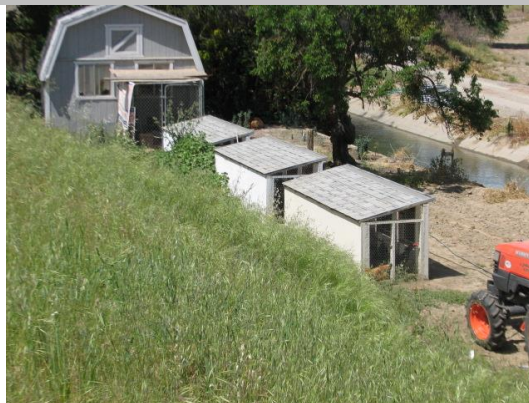
Photo 2 of 2 : SP_2015_RD1500_189_7_20150401_00006.jpg

Chicken coupes have been added along the toe of the levee. Spring 2014

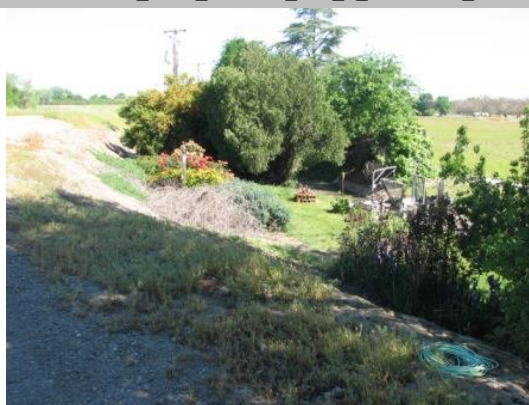
Photo 1 of 1 : SP_2015_RD1500_189_8_20150401_00007.jpg

The landscape is planted into the encroachment zone within 15' of the toe.

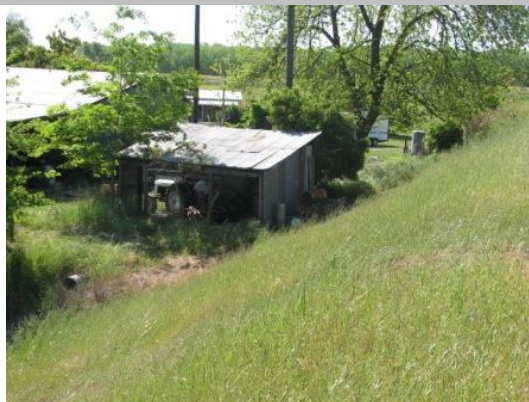
Photo 1 of 1 : SP_2015_RD1500_189_11_20150401_00009.jpg

The equipment shed encroaches into the toe of the levee.

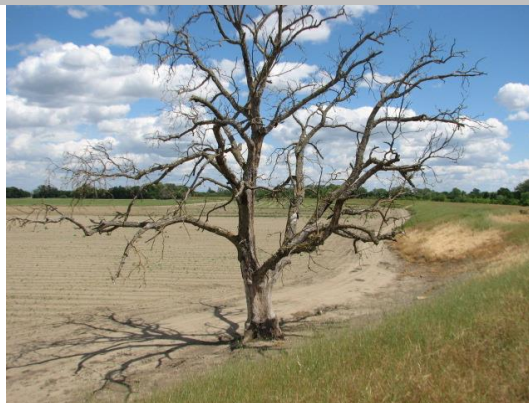
Photo 1 of 1 : SP_2015_RD1500_189_1340_20150401_00083.jpg

Monitor tree that may pose a future threat to the integrity of the levee.
Spring 2014

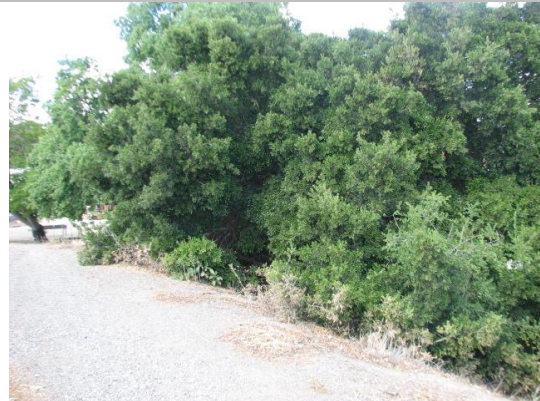
Photo 1 of 1 : SP_2015_RD1500_189_1341_20150401_00084.jpg

Trees need to be trimmed up to at least 5' they are blocking the visibility.
Spring 2014

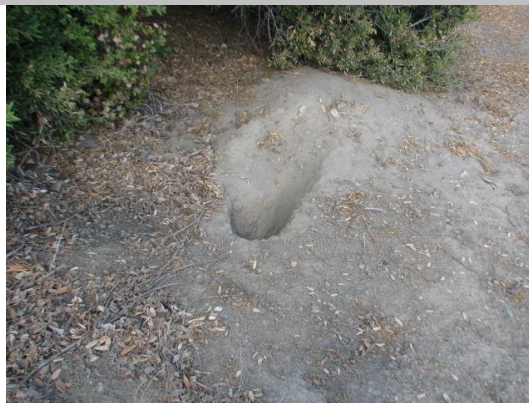
Photo 1 of 1 : SP_2015_RD1500_189_1342_20150401_00085.jpg

A rodent hole on the landside levee slope. Spring 2014

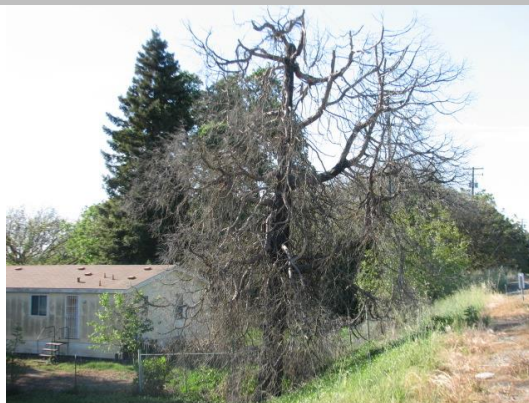
Photo 1 of 1 : SP_2015_RD1500_189_1343_20150401_00086.jpg

Monitor tree that may pose a future threat to the integrity of the levee.
Spring 2014

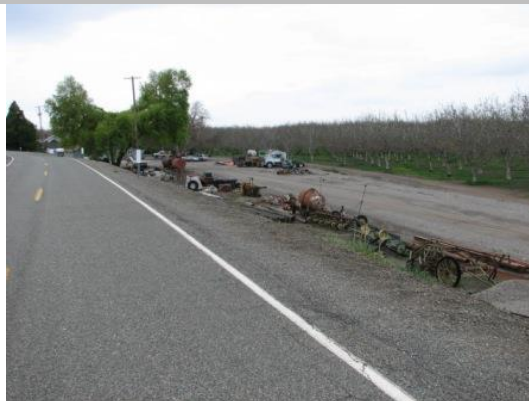
Photo 1 of 1 : SP_2015_RD1500_189_16_20150401_00013.jpg

Equipment along landside toe. Photo was taken in spring 2010.

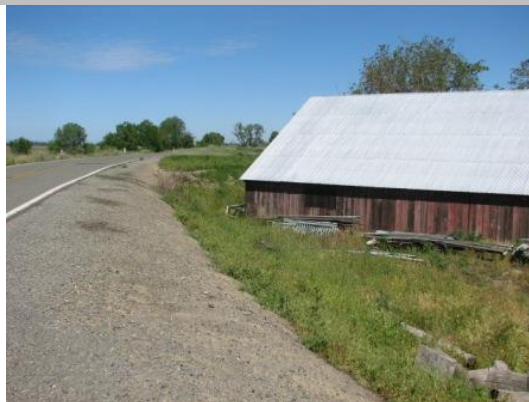
Photo 1 of 1 : SP_2015_RD1500_189_18_20150401_00016.jpg

The corner of the building has encroached into the toe.

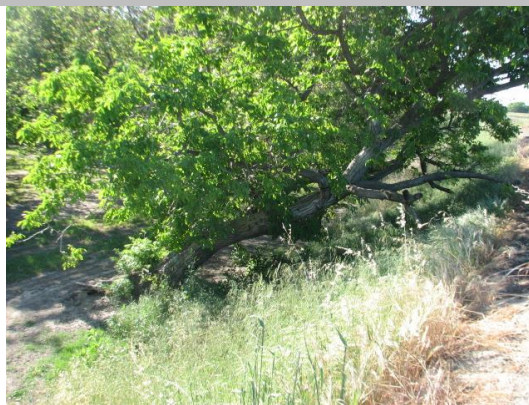
Photo 1 of 1 : SP_2015_RD1500_189_1344_20150401_00087.jpg

The walnut tree at the toe has fallen. The roots are exposed and the branches are holding it up. Spring 2014

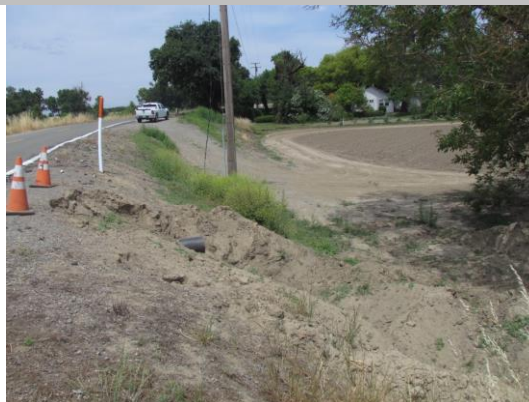
Photo 1 of 2 : SP_2015_RD1500_189_2548_20150514_03095.jpg

View of the dug out pipe on the landward side of the levee looking upstream. Spring 2015.

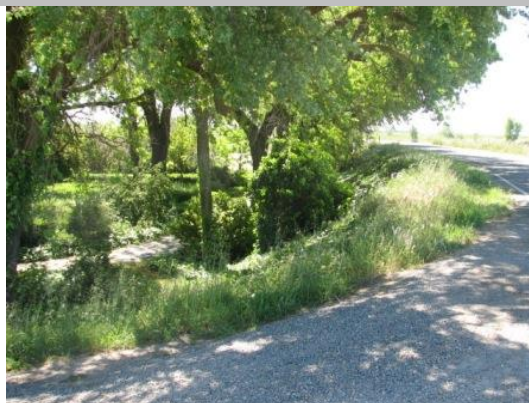
Photo 1 of 1 : SP_2015_RD1500_189_20_20150401_00017.jpg

The homeowner has landscaped the levee slope.

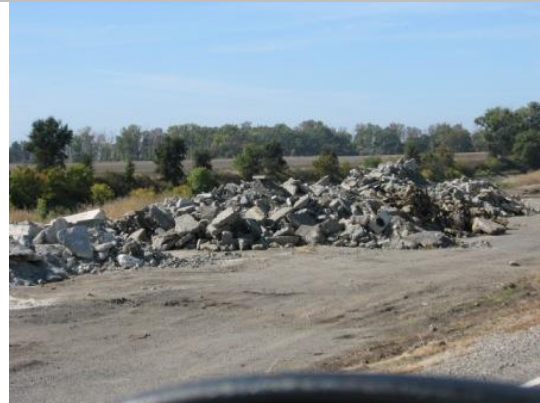
Photo 1 of 2 : SP_2015_RD1500_189_219_20150401_00068.jpg

Concret debris stockpiled on the waterside. Fall 2013

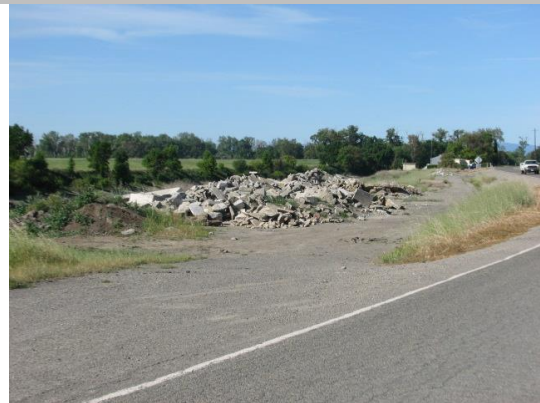
Photo 2 of 2 : SP_2015_RD1500_189_219_20150401_00069.jpg

Concrete debris is along the berm area. Spring 2014

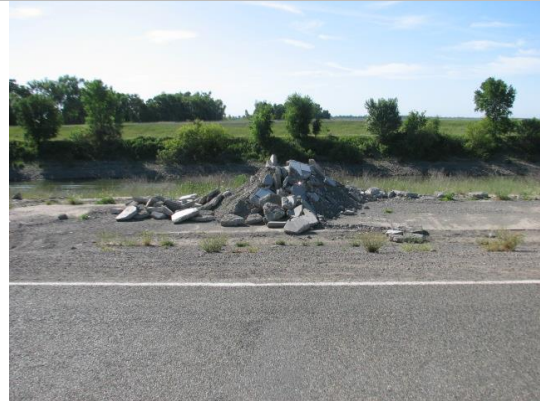
Photo 1 of 1 : SP_2015_RD1500_189_1346_20150401_00089.jpg

A concrete debris pile is on the berm area. Spring 2014

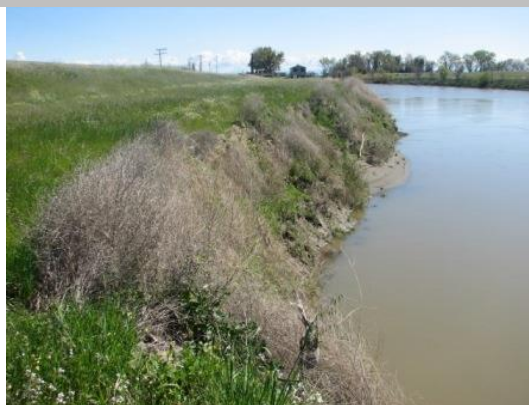
Photo 1 of 1 : SP_2015_RD1500_189_50_20150401_00039.jpg

An erosion site along the embankment, photo taken spring 2012.

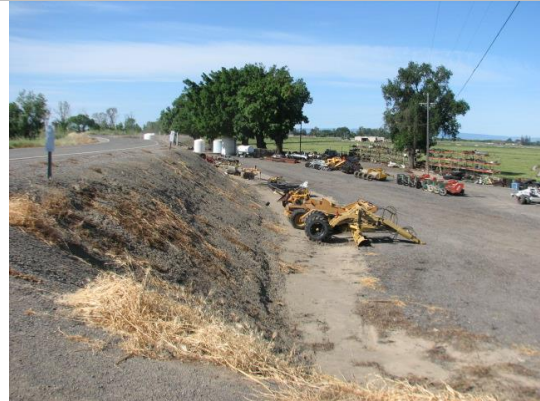
Photo 2 of 2 : SP_2015_RD1500_189_24_20150401_00022.jpg

A current view of the equipment parked along the levee toe Spring 2014

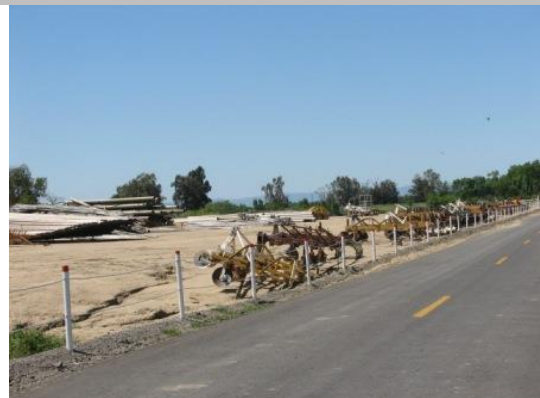
Photo 1 of 1 : SP_2015_RD1500_189_25_20150401_00023.jpg

On top of the crown is farm equipment and irrigation pipe.

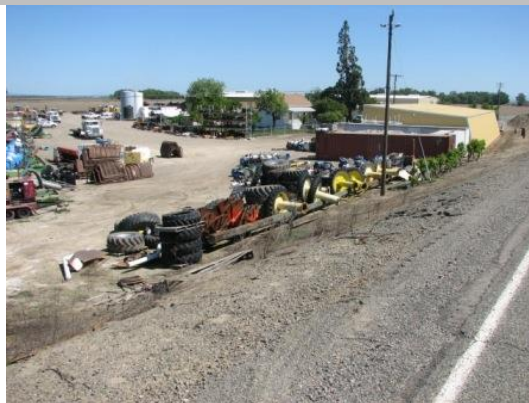
Photo 1 of 1 : SP_2015_RD1500_189_992_20150401_00079.jpg

Next to the building there are tires and axles stored at the toe.

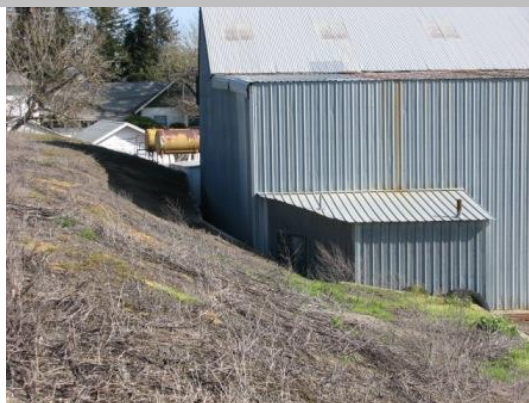
Photo 1 of 1 : SP_2015_RD1500_189_30_20150401_00027.jpg

Building and wall into levee. Photo was taken in spring 2010.

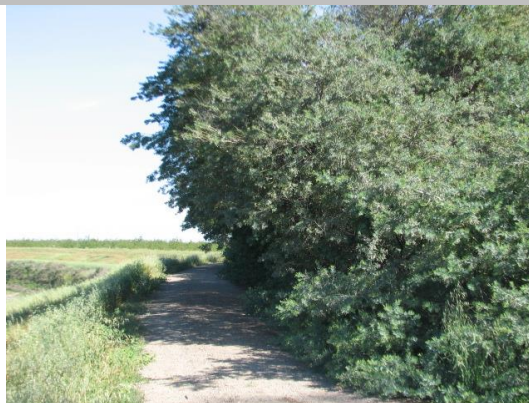
Photo 2 of 2 : SP_2015_RD1500_189_77_20150401_00057.jpg

The trees on the levee slope completely blocks visibility. Spring 2014

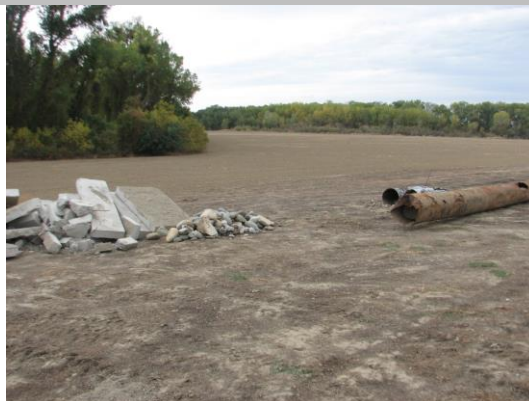
Photo 1 of 1 : SP_2015_RD1500_189_110_20150401_00064.jpg

Broken concrete and a pipe.

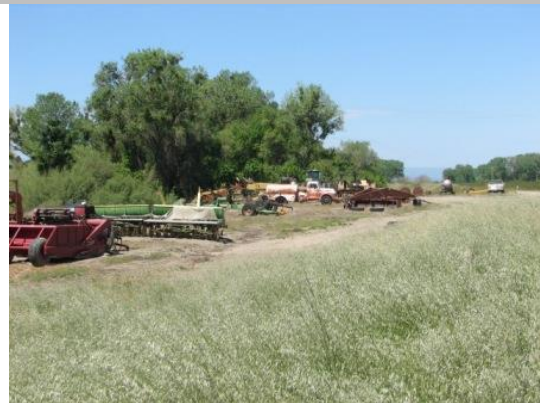
Photo 1 of 1 : SP_2015_RD1500_189_32_20150401_00029.jpg

Farm equipment has been parked on the waterside berm.

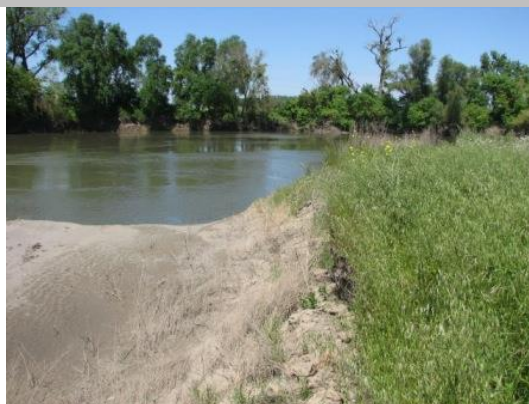
Photo 1 of 2 : SP_2015_RD1500_189_51_20150401_00040.jpg

This is an upstream view of the same erosion.

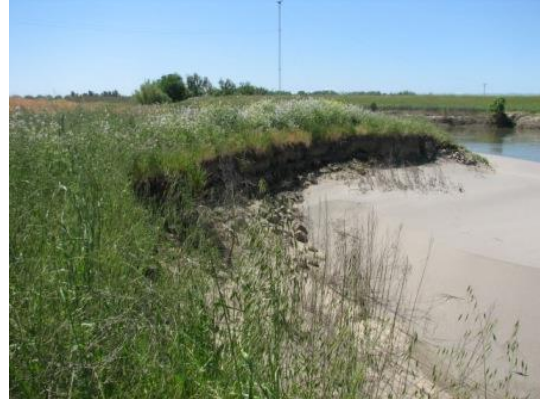
Photo 2 of 2 : SP_2015_RD1500_189_51_20150401_00041.jpg

This is an inside curve in the river and erosion has occurred.

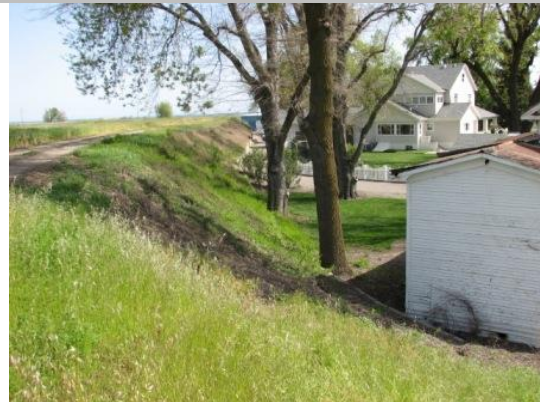
Photo 1 of 1 : SP_2015_RD1500_189_36_20150401_00032.jpg

Building and wall into levee with landscape, photo taken in spring 2010.

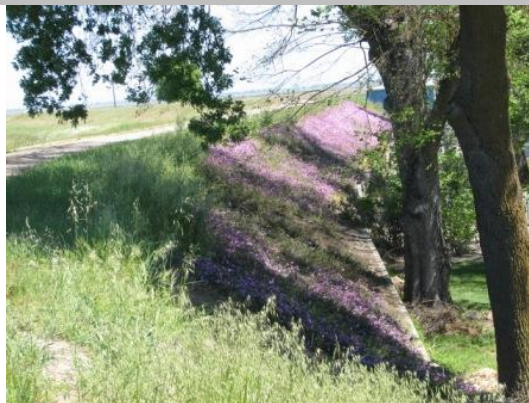
Photo 1 of 1 : SP_2015_RD1500_189_37_20150401_00033.jpg

The groundcover is on the levee slope above the concrete retaining wall.
The groundcover is irrigated.

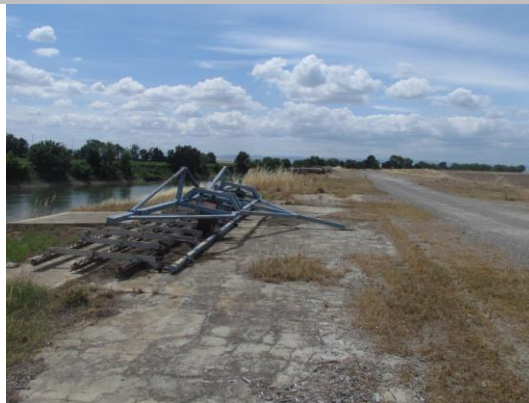
Photo 1 of 1 : SP_2015_RD1500_189_2549_20150514_03097.jpg

View of the equipment on the waterward side of the levee looking upstream. Spring 2015.

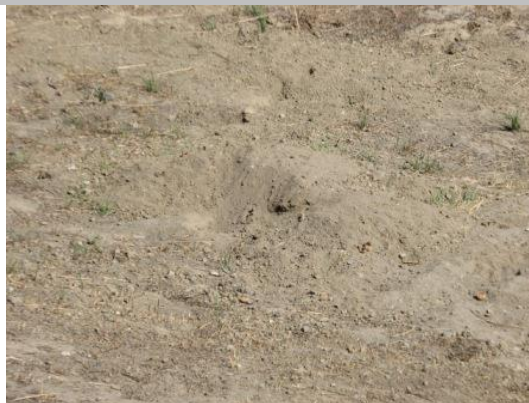
Photo 2 of 2 : SP_2015_RD1500_189_69_20150401_00049.jpg

A rodent burrow on the landside Fall 2013

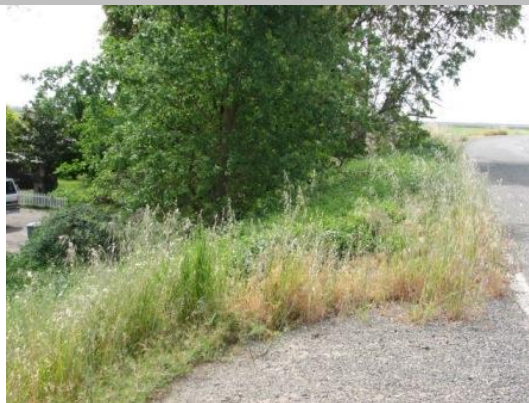
Photo 1 of 1 : SP_2015_RD1500_189_45_20150401_00037.jpg

The groundcover in the landscape makes it hard to see the levee slope.

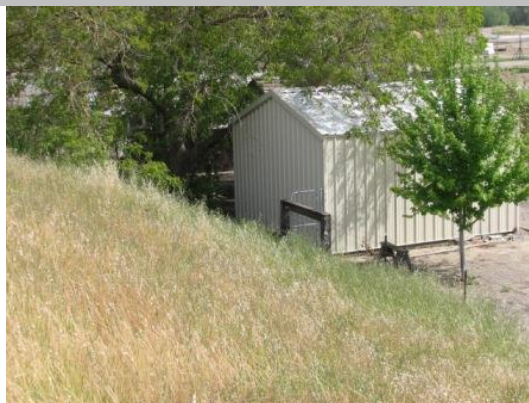
Photo 1 of 1 : SP_2015_RD1500_189_46_20150401_00038.jpg

The building is within the easement of the levee toe.

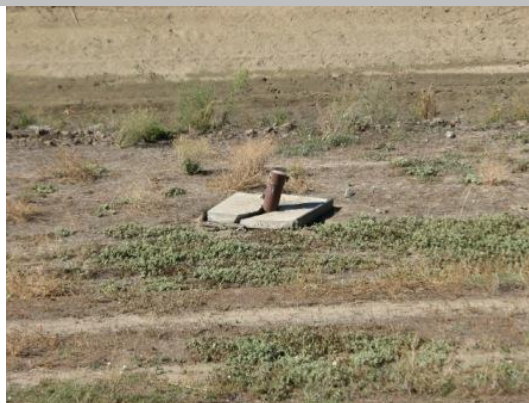
Photo 1 of 2 : SP_2015_RD1500_190_10_20150401_00002.jpg

The pieces of the puzzle have been placed back. Unsure if repaired. Fall 2013

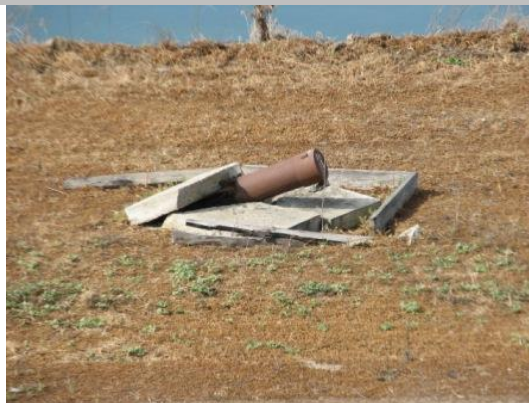
Photo 2 of 2 : SP_2015_RD1500_190_10_20150401_00003.jpg

The seepage well and pad needs to be repaired, Spring 2013
